Yessine AYED, Guénaél GERMAIN, Amine AMMAR, Benoit FURET - Tool wear analysis and improvement of cutting conditions using the high-pressure water-jet assistance when machining the Ti17 titanium alloy - Precision Engineering - Vol. 42, p.294-301 - 2015

Tool wear analysis and improvement of cutting conditions using the high-pressure water-jet assistance when machining the Ti17 titanium alloy

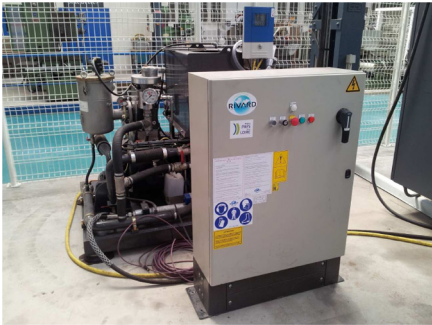
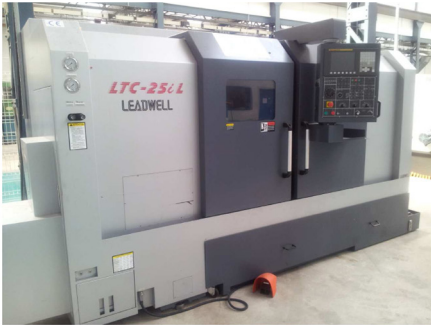
Fig. 2. (a) High-pressure pump, (b) CNC lathe.

All machining operations have been carried out with a “LEAD-WELL LTC25iL” CNC lathe (Fig. 2). A high-pressure pump has been used to supply the high-pressure jet (400 bar, 38 l/min). The pump tank is filled with 200 L of lubricant consisting of 95% water and 5% soluble oil. The experimental setup is illustrated by Fig. 3
